## Sample Report Mytoor, England, MYTOOR SAMPLE

**TENANT NAME**  
Sample Tenant

**PROPERTY VISIT DATE**  
01/04/2019

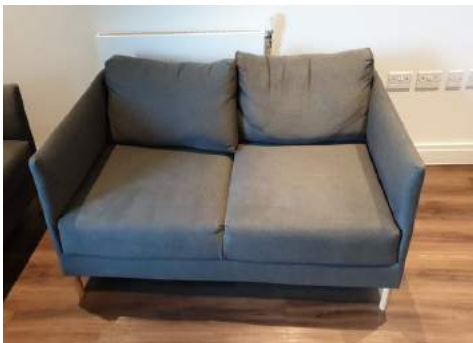
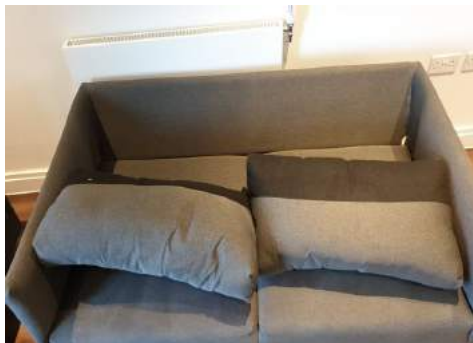
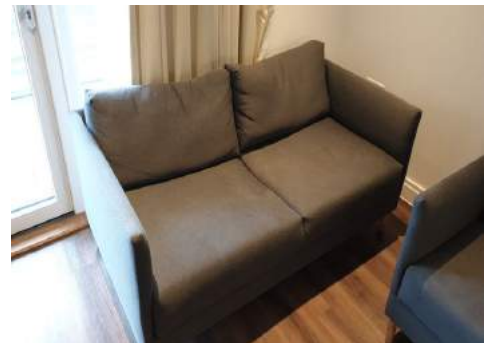
## Sofa

| Item | Description | Condition | Cleanliness |
|---|---|---|---|
| <b>Sofa</b> (3 photos) | 2 seater. Fabric upholstered X 2 in total. Free of tears, scuffs, however stain present to the back of RHS cushion to sofa next to balcony. Wear evident. | ● Good | ● Fair |

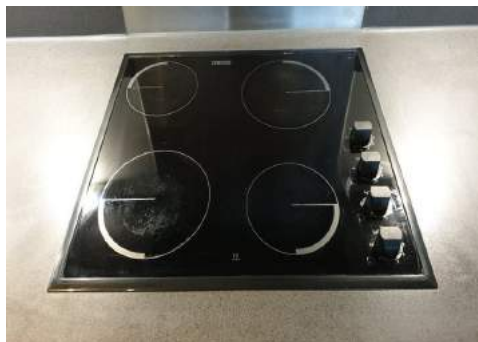
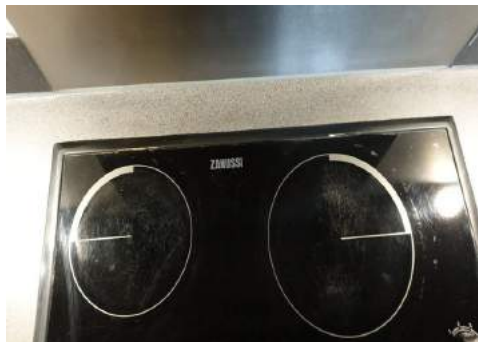
## Hob

| Kitchen | | | |
|---|---|---|---|
| Hob (5 photos) | Ceramic hob. 4 rings. Zanussi Free of grease and food residue. Free of dust. Dials/knobs intact. X 2 rings have burnt on residue and are soiled. | ● Good | ● Fair |
