## Sample Report Mytoor, England, MYTOOR SAMPLE

**TENANT NAME**  
Sample Tenant

**PROPERTY VISIT DATE**  
01/04/2019

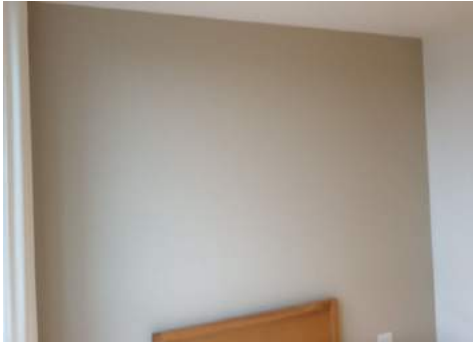
## Walls

| Item | Description | Condition | Cleanliness |
|---|---|---|---|
| <b>Walls</b> (2 photos) | Plastered & painted<br>1 x feature wall. ML smudge present to LHS of the wardrobe at ML. Otherwise free of marks stains and scuffs. No picture hooks, raw plug or filled holes present. | ● Good | ● Good |

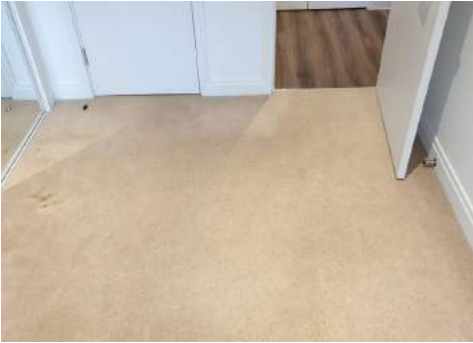
Floor

| Item | Description | Condition | Cleanliness |
|---|---|---|---|
| <b>Floor</b> (5 photos) | Carpeted. Beading/trim present<br>Stain present in front of wardrobe (hand size). Door stop present to the bathroom. Door stop present to to entrance door (fixed to the skirting). | ● Good | ● Fair |

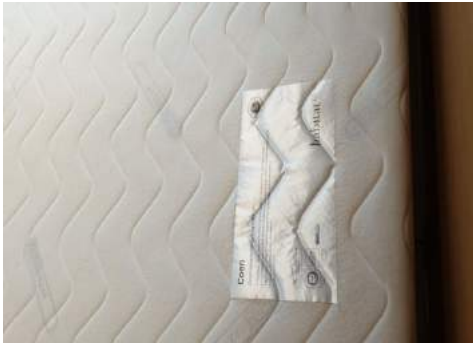
## Mattress

| Item | Description | Condition | Cleanliness |
|---|---|---|---|
| <b>Mattress</b> (4 photos) | Memory foam. Fire safety label present<br>Appears free of stains and tears. | ● Good | ● Excellent |
